Site/Project Location: West Side HDD Bore Missouri River

Date of Inspection: 11 August 2016

Site/Project Location: Slip HDD South of Little Missouri River

Site/Project Location: MP 13 Pipeline ROW McKenzie County Rd 37 **Date of Inspection:** 20 July 2016

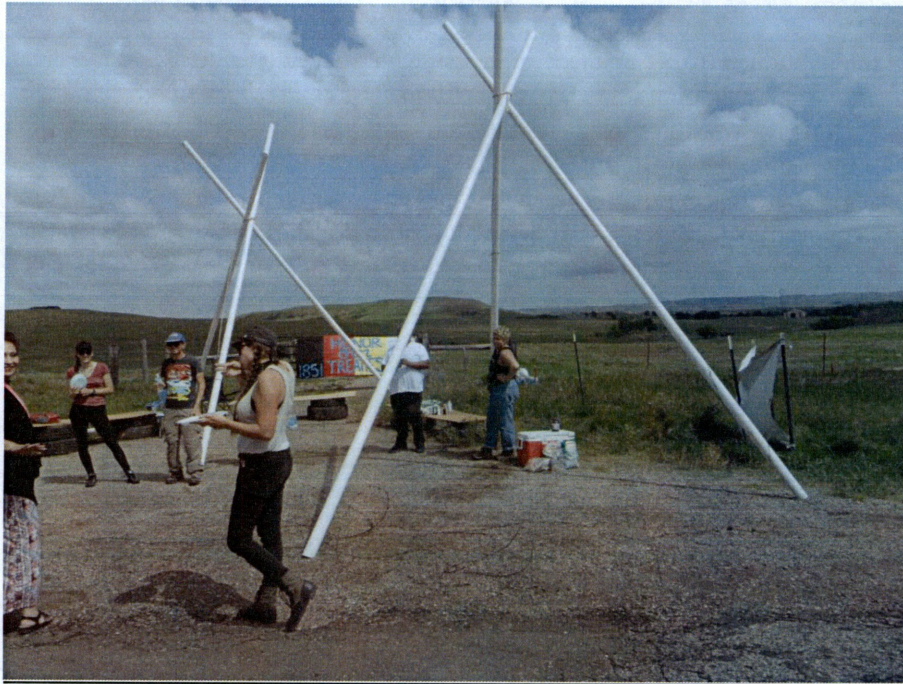
Protestors at both project access points off ND Highway 1806. Timetable for resolution unknown.

Report Photo #1 "Protest Area - North Site":

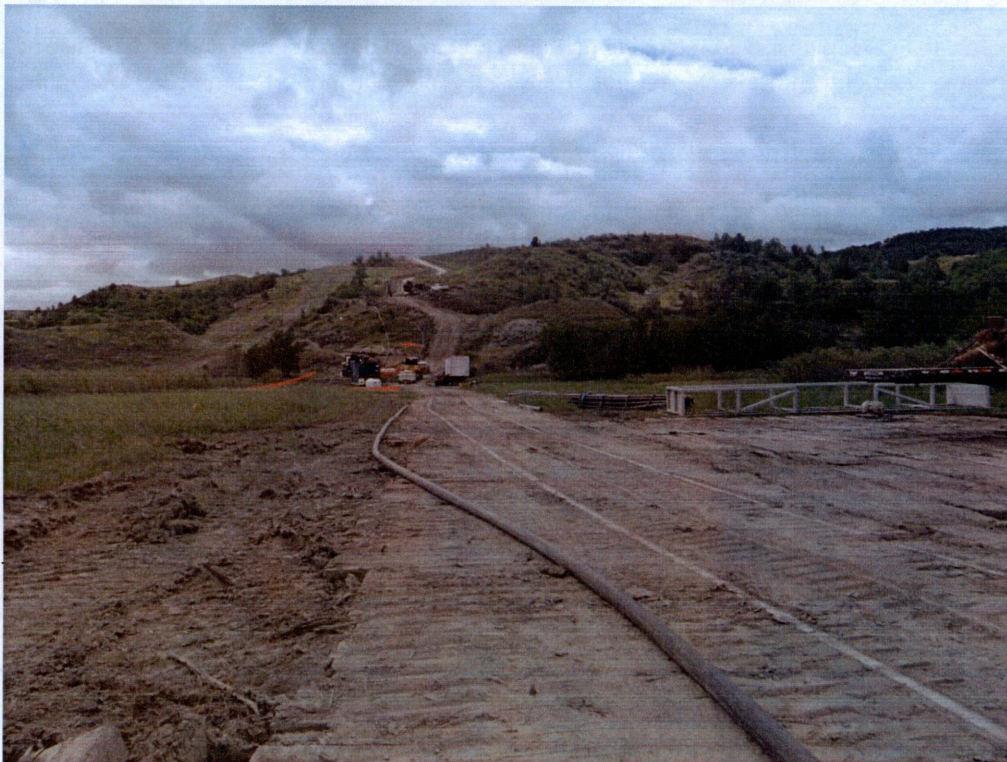
Report Photo #1 "Overall Site Looking South Toward Backside of Prior Slip": 47.6069°N 102.8765°W

NOTE: Bridger ROW to 50 feet to east (left)

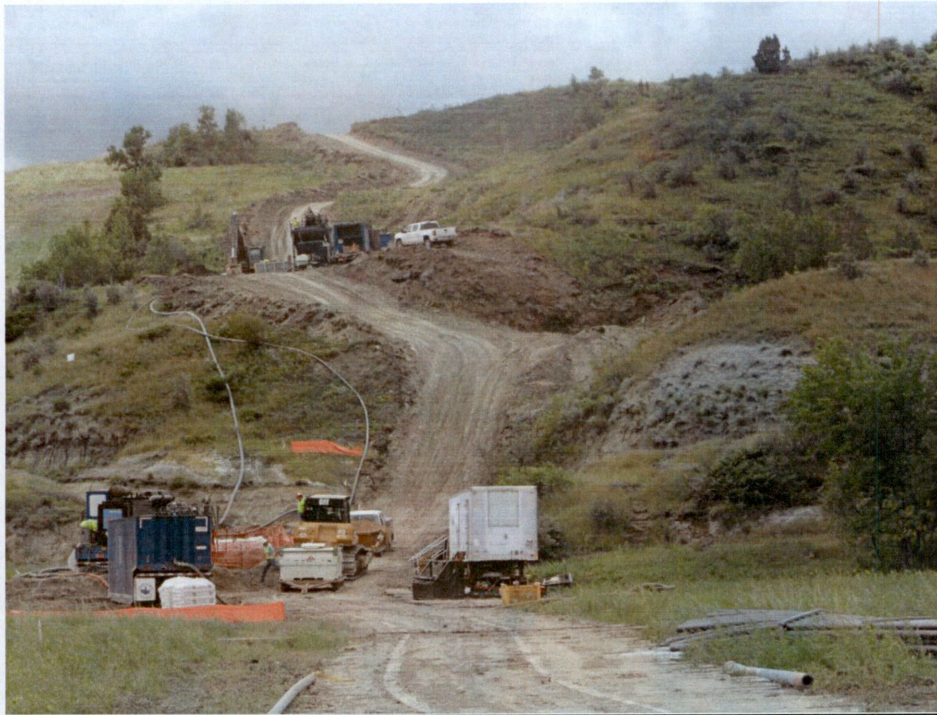
Report Photo #2 "Looking South Toward Equipment Staging on North Slope": 47.6082°N 102.8765°W

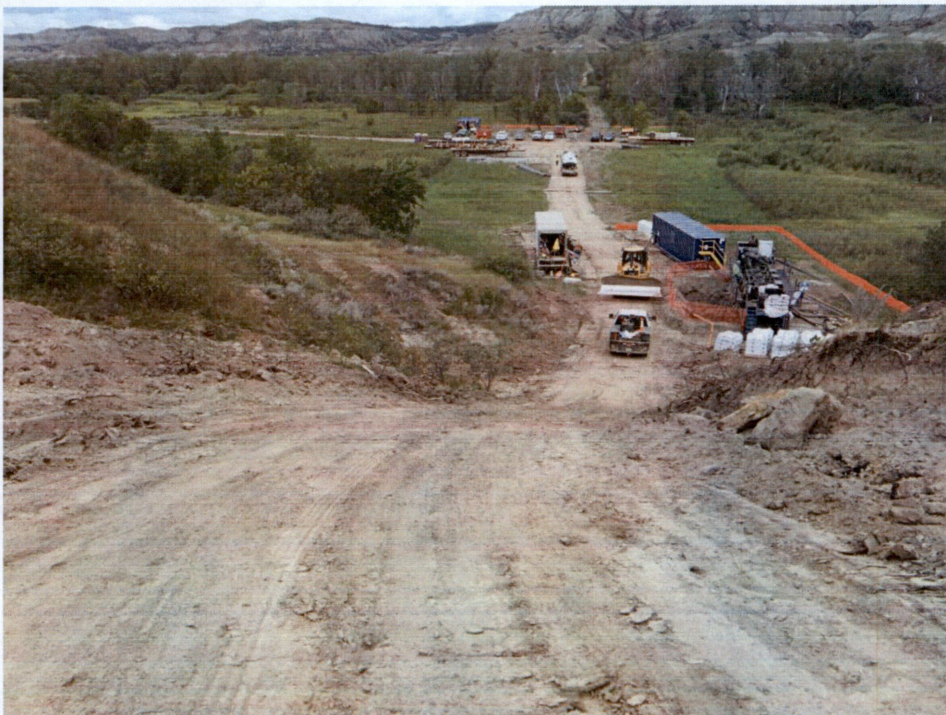
Report Photo #3 "Overview Site Looking North from Slip Bore Machine Level": 47.6072°N 102.8764°W

NOTE: Mud Mix-Trailer and Overflow Pit on east (right)

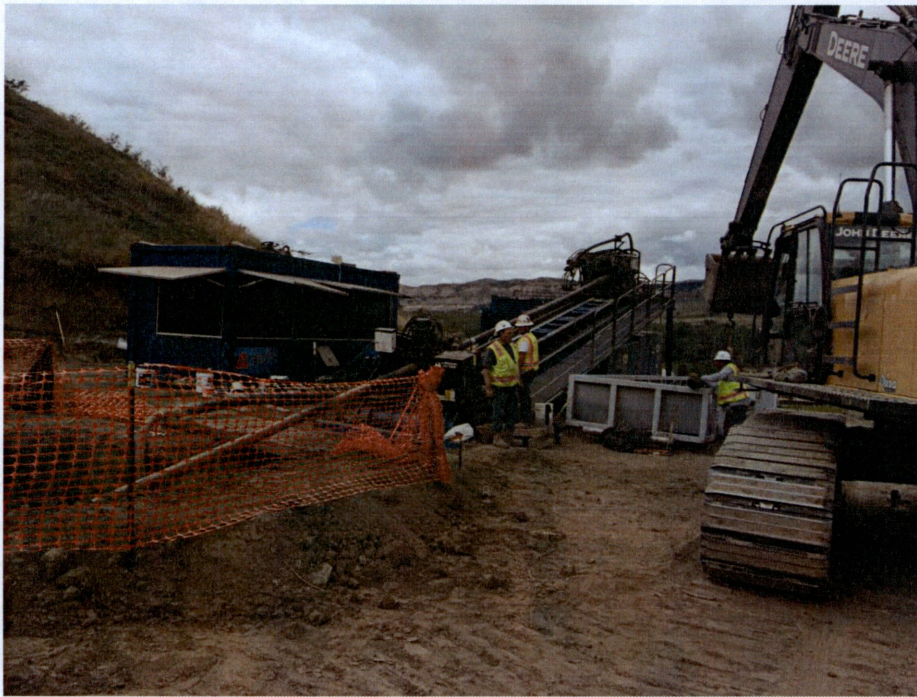
Report Photo #4 "Bore Machine":

Visit to north side of bore site of HDD bore machine. Tree & shrub removal complete. Surface stripping complete. HDD bore machine position partially uphill. Mud mix-trailer including water and bentonite material staging located at base of hill. Mud transferred to bore pit via hoses. Transcube fuel tank in use at mud mix-trailer and operation/placement adequate. Operators report expected 2700 feet of expected bore length. Access road including topsoil stripping installed across crest of hill above bore path.

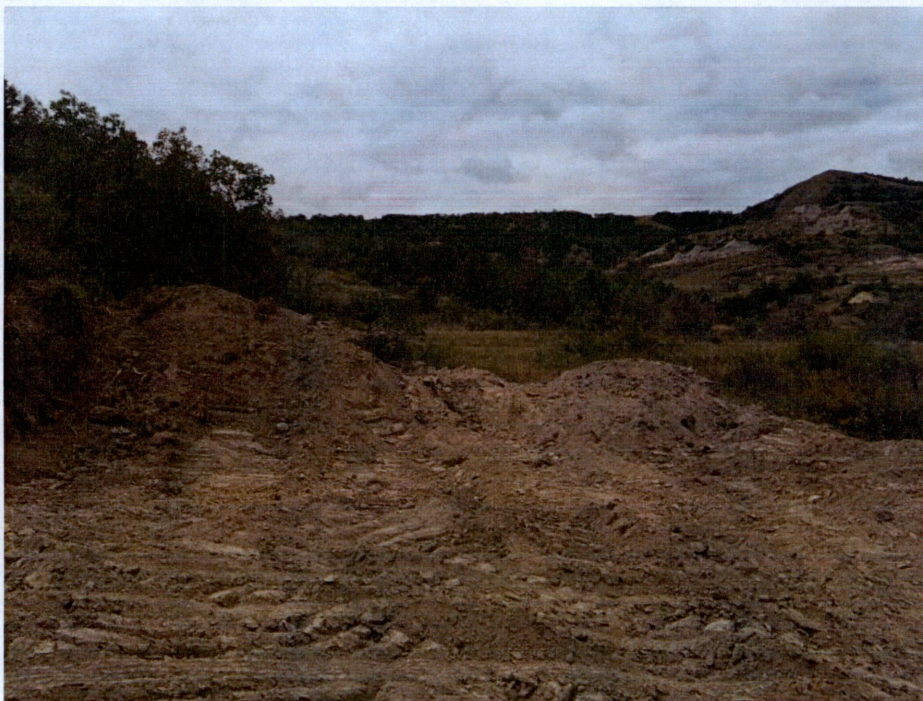
One area of topsoil stacked on top of stripped subsoil.

Report Photo #5 "Marginal Topsoil Segregation":

NOTE: Topsoil stacked on subsoil

Moving topsoil pile on subsoil would likely be as much if not more damaging as leaving it at current location. Recommend leaving the soil pile at its current location.

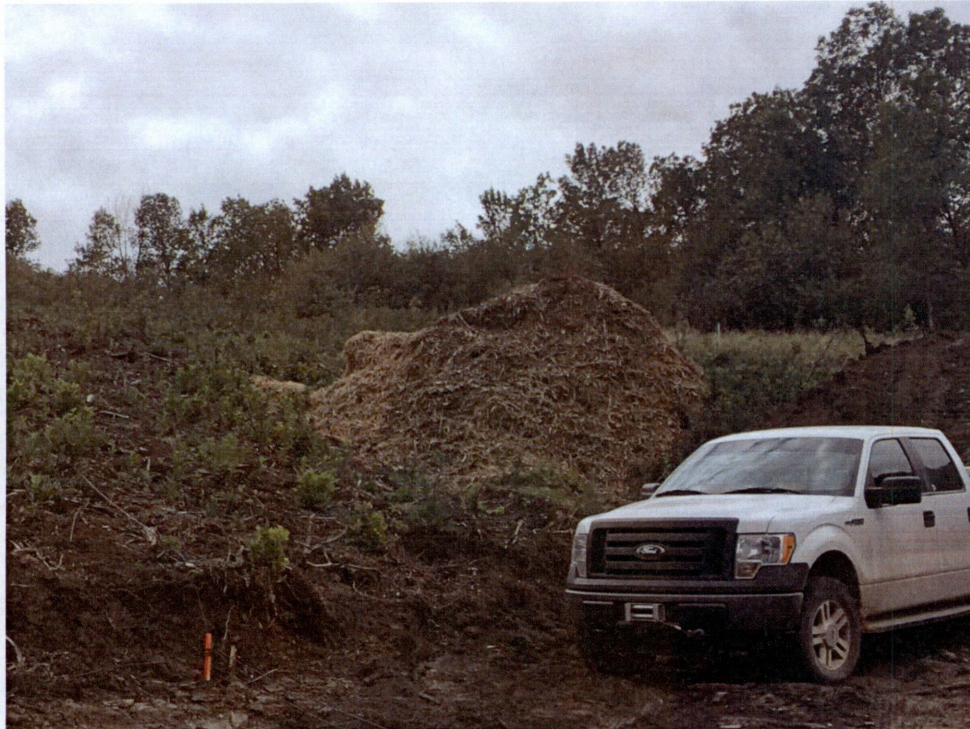
Tree/shrubs removal in area immediately south of river very narrow, reportedly only 35 feet wide. Full width tree/shrub removal in current work area. Piles of wood chips noted within ROW work areas. Project staff reported they will be removed from ROW and not used during remediation. Asked to see tree count and removal tally. Project staff reported they were still waiting for that information as well from their project's environmental staff.

Report Photo #6 “Chipped Wood Pile on West Side of ROW”:

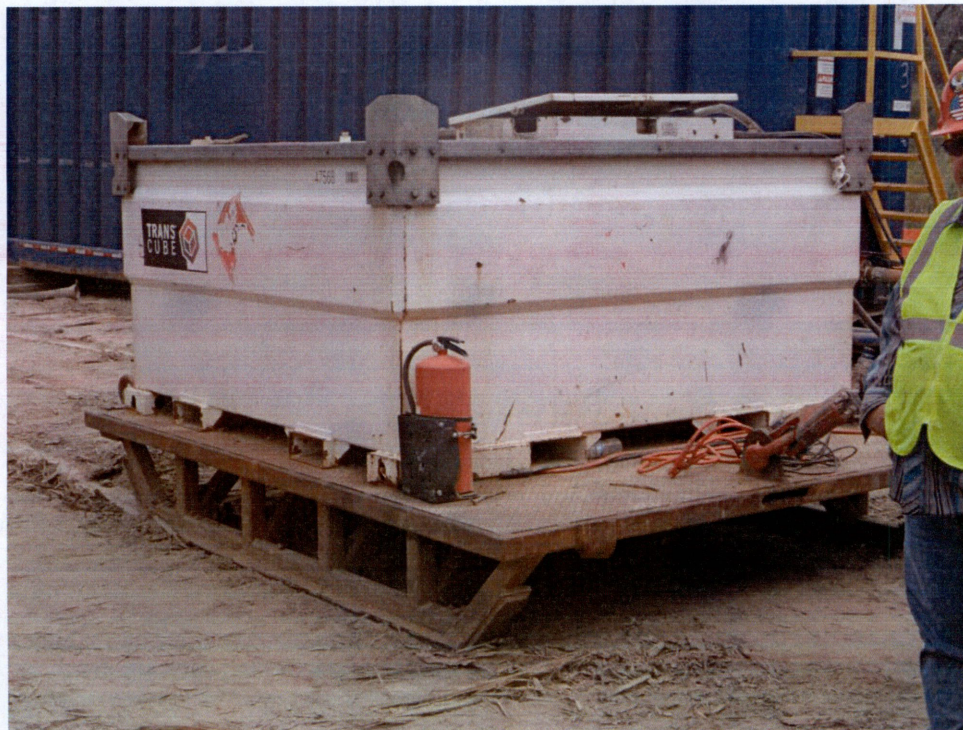
Report Photo #7 “Transcube Fuel Container”:

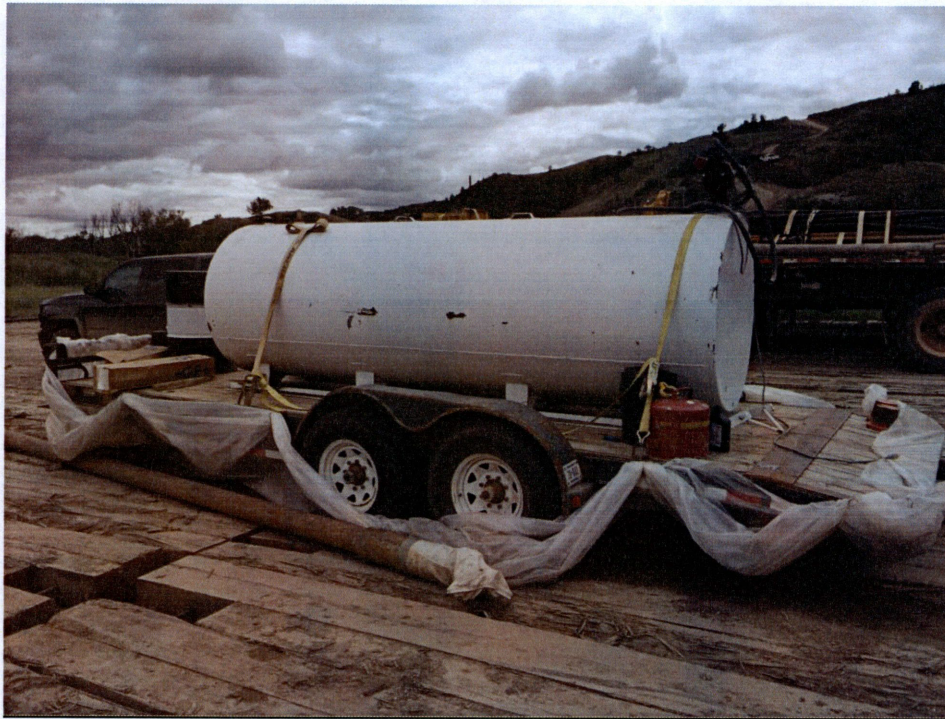
Secondary fuel tank located at worksite trailer has been at site for four (4) days protected only by plastic sheeting beneath tank.

Report Photo #8 "Fueling Trailer" at GPS Coordinates: 47.6087°N 102.8765°W

Site personnel understood, without prompting, that the secondary containment for the fuel trailer was not adequate. Possible modifications were discussed to correct item. Staff indicated it would be corrected in less than two (2) days.

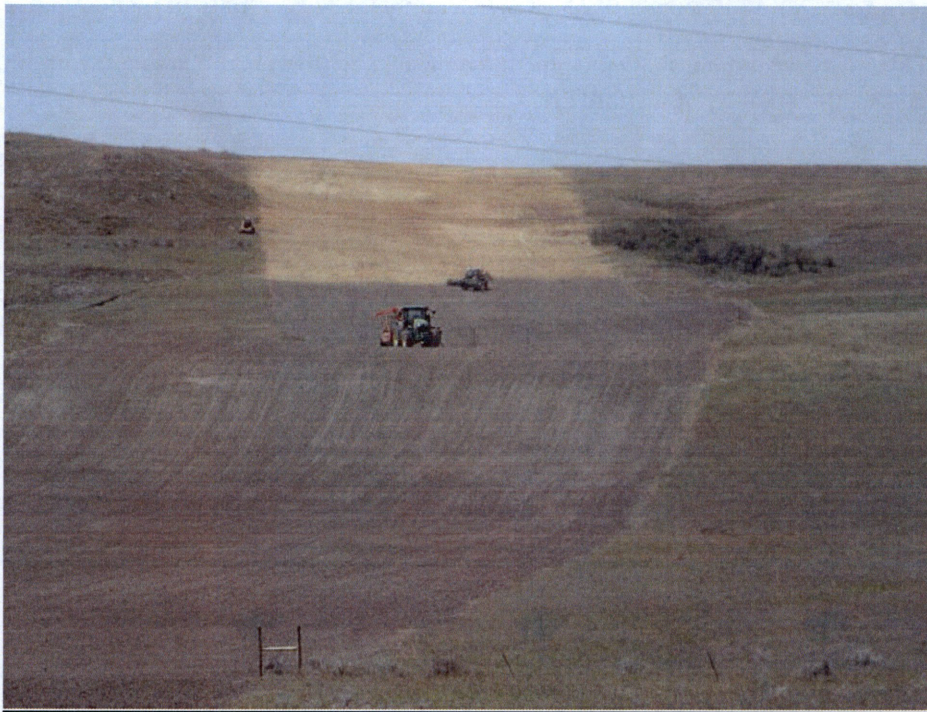
Stormwater BMPs had been removed from both areas if the ROW. Shredded straw and crimping underway on sloped areas of ROW on west side of McKenzie County Road 37. Topography restored to apparent prior condition and elevation.

Report Photo #1 "Pipeline ROW West of County Road 37 (Zoomed)" Looking W: 47.7833°N 103.2192°W

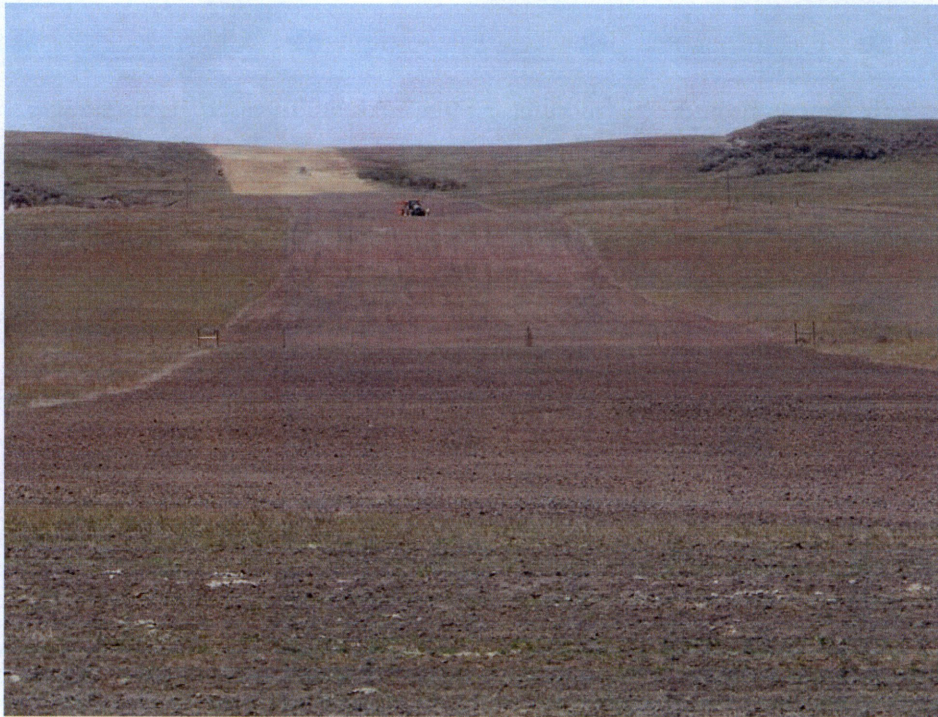
Report Photo #2 "Pipeline ROW West of County Road 37" Looking West:

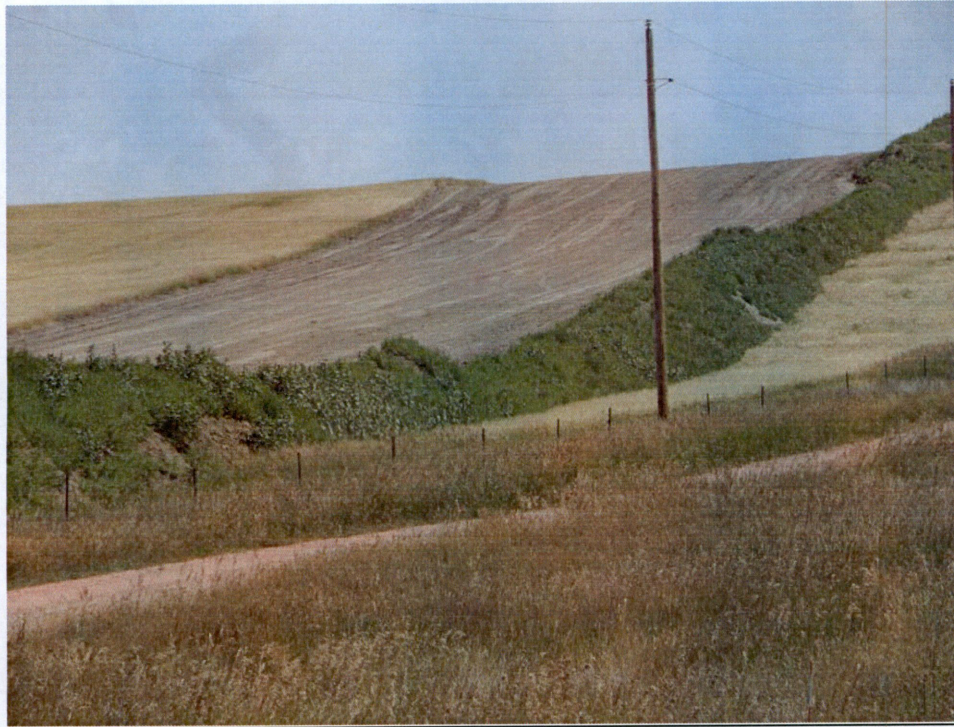
On east side of McKenzie County Road 37, topography restored to apparent prior condition and elevation. Subsoil smoothly replaced across entire ROW. Top soil windrows still in place.

Report Photo #3 "Pipeline ROW East of County Road 37" Looking ENE:
